ANALYSIS OF THE FACTORS RESPONSIBLE FOR RIVER BANK EROSION
: A STUDY IN BERHAMPORE BLOCK, MURSHIDABAD DISTRICT,
WEST BENGAL.

ABSTRACT:

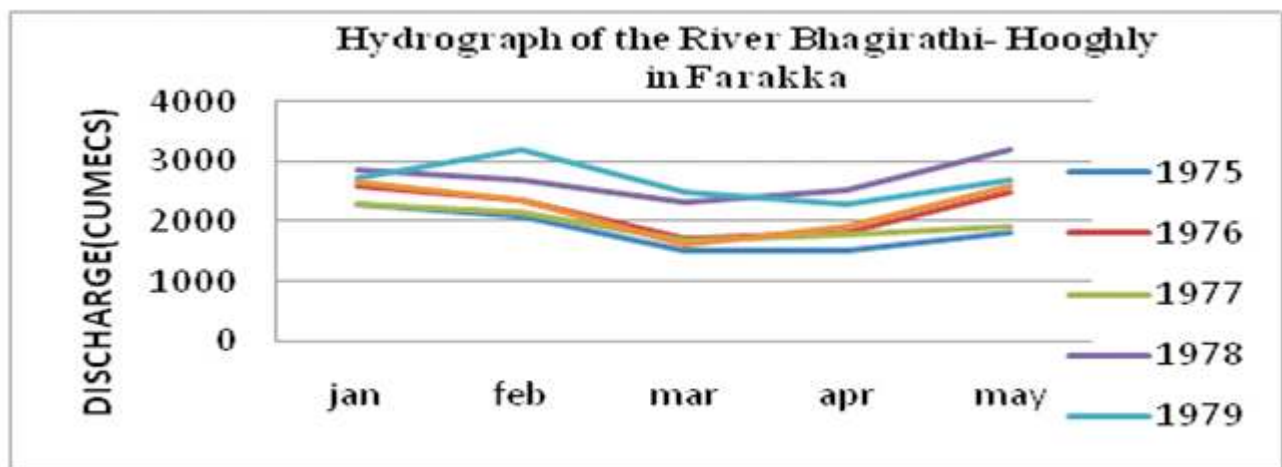
Figure 2: Source Erosion in Bhagirathi. 2000, A case Study in Farakka.

This diagram (figure-1) is the hydrograph of the river in Farakka in from 1975-1979. From this diagram it is clear that the construction of the barrage has regulated the discharge of water of the river. In 1977, when the minimum discharge of the river was 1999 cumecs, it turned to below 1000 cumecs in 2000. The most notable change is observed from July. In 1970, the July discharge was 22358 cumecs whereas in 2000, July, the maximum discharge was 1500 cumecs and the average discharge was, between 1000 and 1500 cumecs. The September discharge was the highest. In 1970 the September discharge was, 38992 cumecs and the regulated discharge in 2000 was only nearly 3000 cumecs. Therefore the control of water in the Farakka is notably important in the process of river shifting. A continuous discharge is not that effective in bank erosion as compared to a sudden high discharge. The problem of river shifting in Nadia lies here. It happens that Farakka barrage at

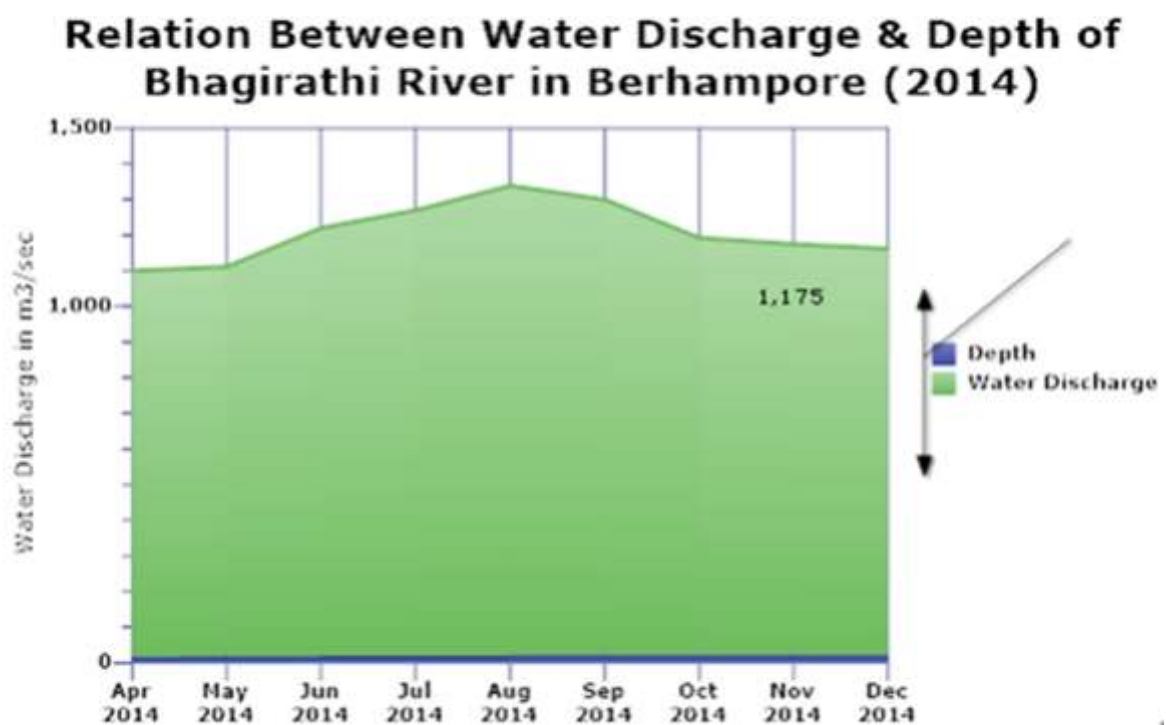
Figure 3: Water Discharge & Depth of Bhagirathi at Berhampore Unit

Source: Data collect from Central Water Commission, Berhampore

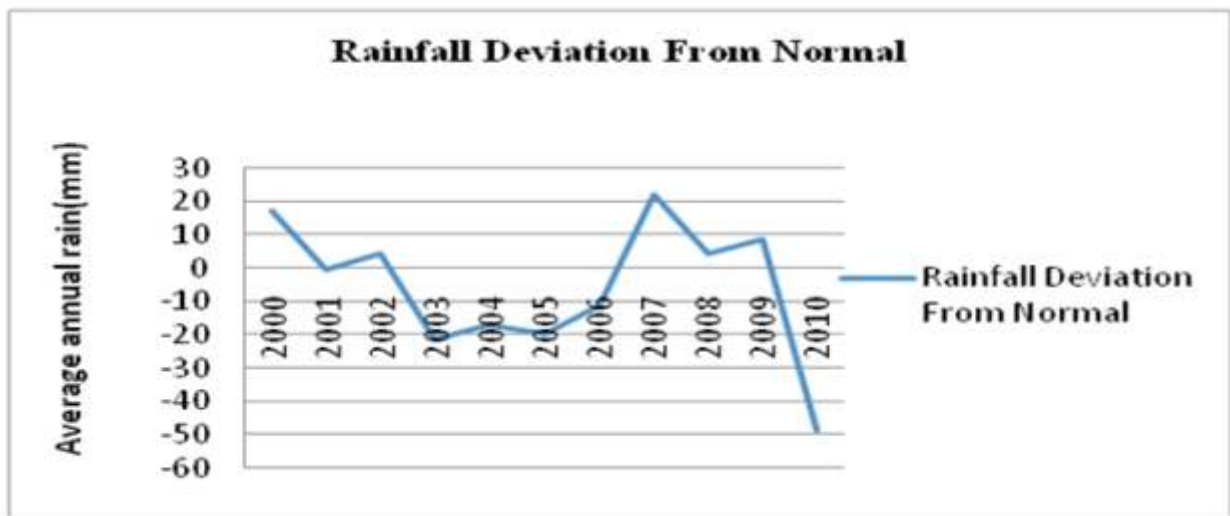
Figure 5: Rainfall Deviation from Normal in Murshidabad District.

Source: District Statistical handbook 2010, Murshidabad.

Here it is found that, only in 2001, rainfall was near normal. Otherwise, rainfall is very high or very low and fluctuation has become more or less a normal phenomenon here. Both rainfall and runoff factors must be considered in assessing a water erosion problem. The impact of raindrops on the soil surface can break down of soil aggregates disperse the aggregate material. Lighter aggregate materials such as very fine sand, silt, clay and organic matter can be easily removed by the raindrop splash and runoff water; greater raindrop energy or runoff amounts might be required to move the larger sand and gravel particles. Soil movement by rainfall (raindrop splash) is usually greatest and most noticeable during short-duration, high intensity thunderstorms. Although the erosion caused by long-lasting and less intense storms is not as spectacular or noticeable as that produced during thunderstorms, the amount of soil loss can be significant, especially when compounded over time. Runoff can occur whenever there is excess water on a slope that cannot be absorbed into the soil or trapped on the surface. The amount of runoff can be increased if infiltration is reduced due to soil compaction, crusting or freezing. Runoff from the agricultural land may be greatest during spring months when the soils are usually saturated.

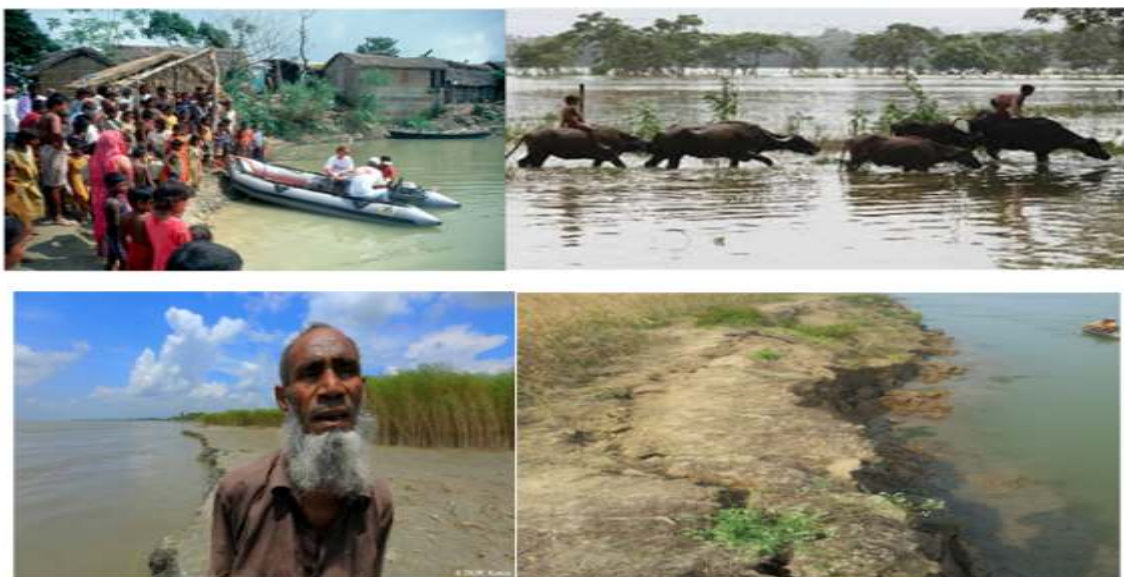
Slope of the area ranges between, 0 degree and 3.5 degrees. It was observed from SRTM data processed by Global Mapper. So that in south –western monsoonal period the river bears large amount of water which causes flood particularly in western bank. Which are depicted in following photos -----

Figure: River Bank Erosion and its Effect as Flood
