Analysis of the Factors Responsible for River Bank Erosion : A Study in Shantipur Block, Nadia District, West Bengal.

Subarna Chatterjee And Biswaranjan Mistri

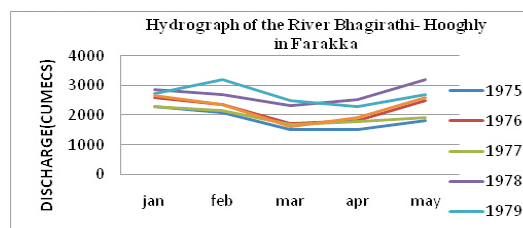
Figure I: Source Erosion in Bhagirathi.2000, A case Study in Malda

Below, are the diagrams which show the discharge of the river Hooghly in Malda.

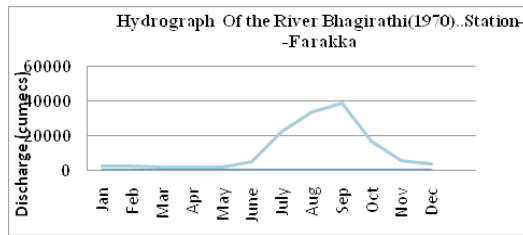
Figure II: Source: Centre for Sustainability and Global Environment Wisconsin Madison.

This is the hydrograph of the year 1970, that is before the Farakka barrage came into operation.

From the two diagrams it is clear that the construction of the barrage has regulated the discharge of water of the river. In 1970, when the minimum discharge of the river was 1999 cumecs, it turned to below 1000 cumecs in 2000. The most notable change is observed from July. In 1970, the July discharge was 22358 cumecs whereas in 2000, July, the maximum discharge was 1500 cumecs and the average discharge was, between 1000 and 1500 cumecs. The September discharge was the highest. In 1970 the September discharge was, 38992 cumecs and the regulated discharge in 2000 was only nearly 3000 cumecs. Therefore the control of water in the Farakka is notably important in the process of river shifting. A continuous discharge is not that effective in bank erosion as compared to a sudden high discharge. The problem of river shifting in Nadia lies here. It happens that Farakka barrage at times emits very large volumes of water mainly during and after rainy season. This sudden emission of a large volume of water, causes slumping of the

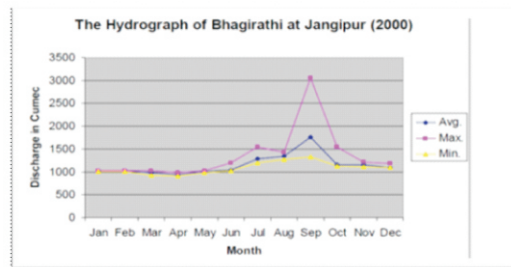
Figure III: Source: KPT, 2000

This diagram is the hydrograph of the river in Jangipur in 2000.

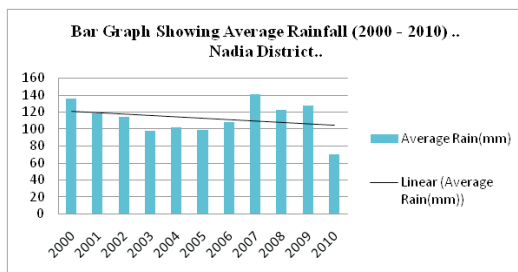
Figure IV: Source: Data from Meteorological Department, India

From the ten years average rainfall diagram of Nadia district, we find that rainfall in the District varies from about 100 to 175 mm. The rainfall is obtained mainly by the south west monsoonal winds and therefore the maximum rainfall occurs in the summer months. 92% of the rainfall is obtained in the period between April and November. According to the villagers surveyed, maximum rainfall occurs in the period between July and September and this is the most vulnerable time of the year when both acute flooding and river bank failure occurs.

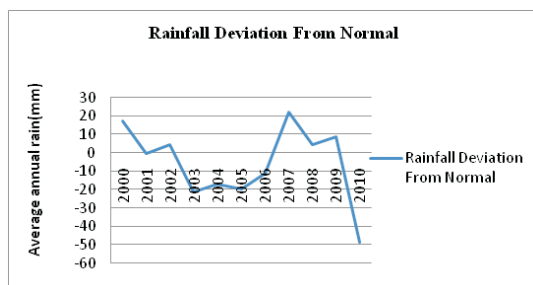
Figure V: Source: District Statistical handbook 2000, Nadia.

Here it is found that, only in 2001, rainfall was near normal. Otherwise, either rainfall is very high or very low and fluctuation has become more or less a normal phenomenon here. Both rainfall and runoff factors must be considered in assessing a water erosion problem. The impact of raindrops on the soil surface can break down of soil aggregates disperse the aggregate material. Lighter aggregate materials such as very fine sand, silt, clay and organic matter can be easily removed by the raindrop splash and runoff water; greater raindrop energy or runoff amounts might be required to move the larger sand and gravel particles. Soil movement by rainfall (raindrop splash) is usually greatest and most noticeable during short-duration, high-intensity thunderstorms. Although the erosion caused by long-lasting and less-intense storms is not as spectacular or noticeable as that produced during thunderstorms, the amount of soil loss can be significant, especially when compounded over time. Runoff can occur whenever there is excess water on a slope that cannot be absorbed into the soil or trapped on the surface. The amount of runoff can be increased if infiltration is reduced due to soil compaction, crusting or freezing. Runoff from the agricultural land may be greatest during spring months when the soils are usually saturated.
